Photographs for Mid City Plating Company CEI 6/22/2010

Media: RCRA

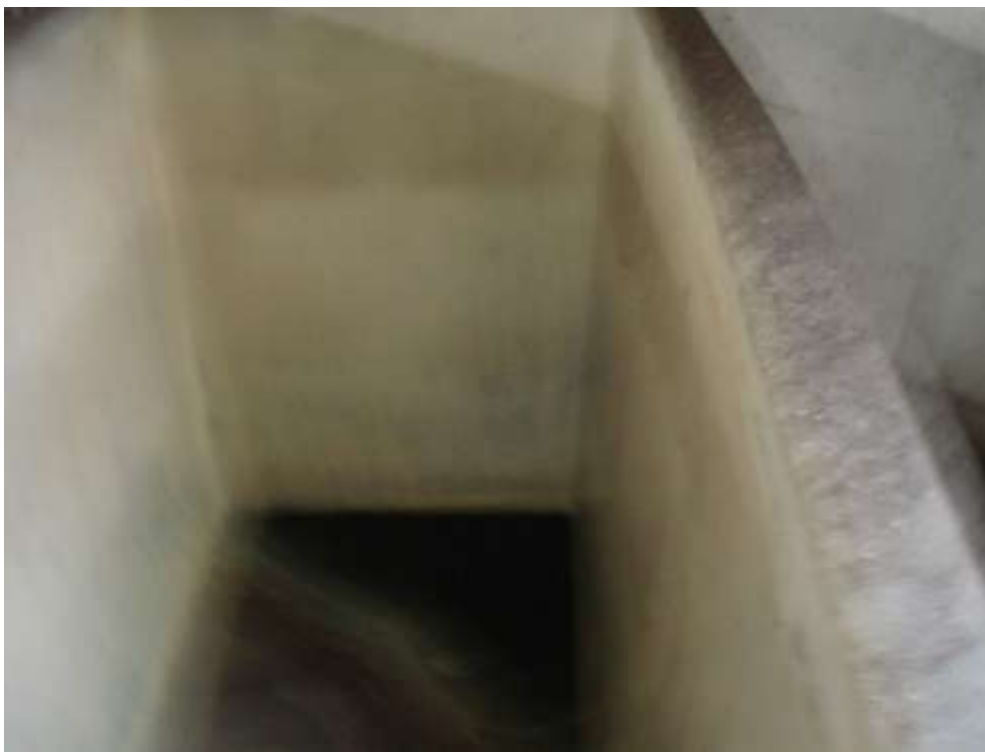
Disk Number 1
Photo Number 48
Photo Filename P6220141.JPG
Date/Time 6/22/2010
10:20:00 AM
Photographer Jamie Paulin

Un-identified liquid was being stored in a bath that had been used in the Barrel Row line plating process.

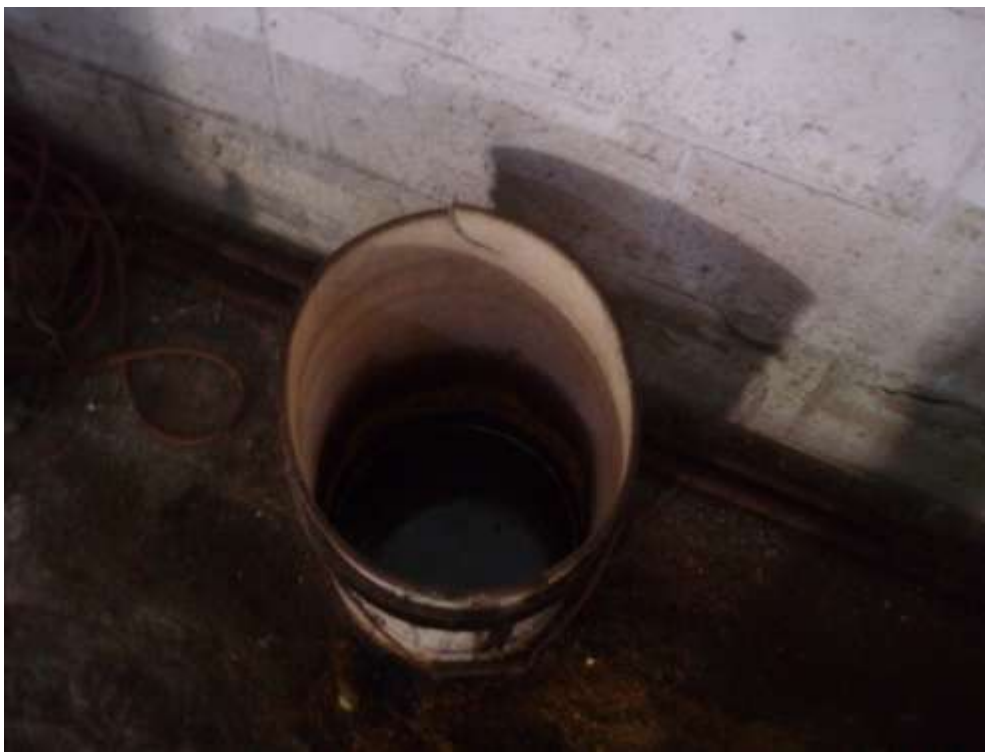
Disk Number 1
Photo Number 49
Photo Filename P6220142.JPG
Date/Time 6/22/2010
10:20:10 AM
Photographer Jamie Paulin

An oily liquid was being stored in an open 5-gallon bucket. The oil was described as hydraulic oil.

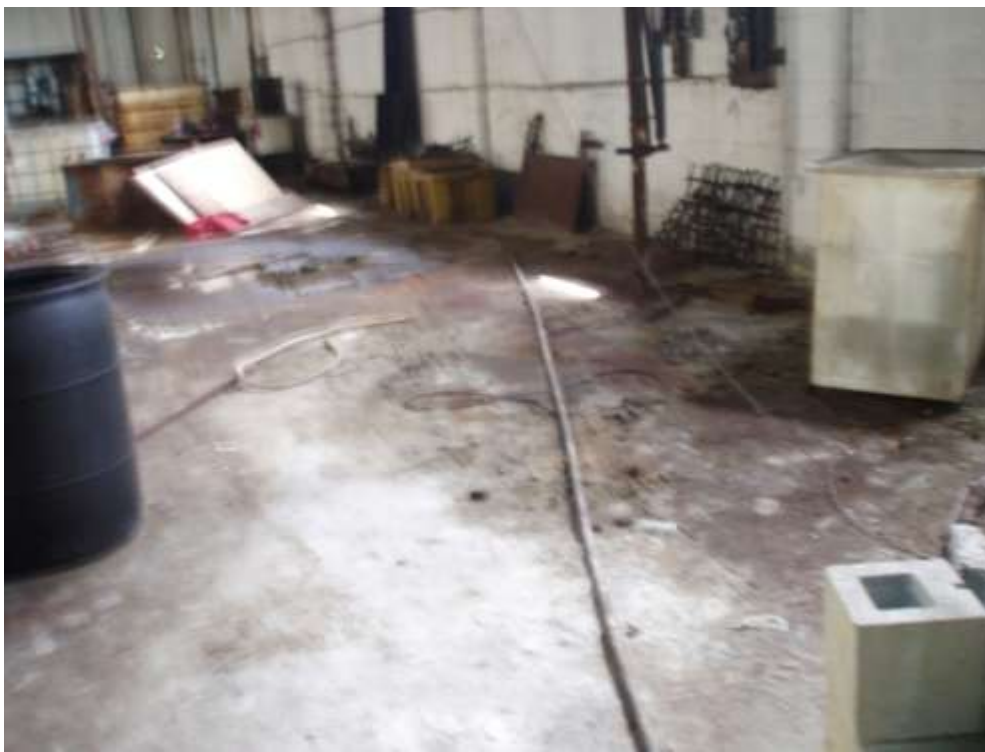
View of floor where the Barrel Row line was once in operation. Liquids and material were being stored on the floor. Various equipment was also being stored within the area.

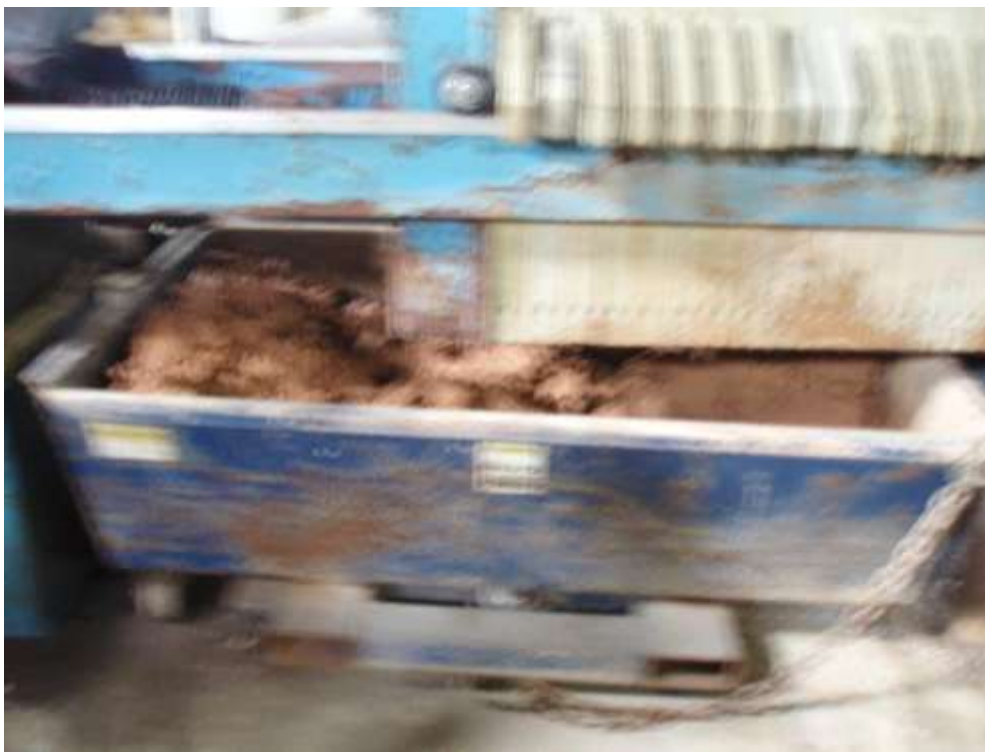
WWT unit filter press. Approximately 1 cubic yard. F006 waste water treatment sludge. Container was open, not labeled with the words, "Hazardous Waste," and not labeled with an accumulation date.

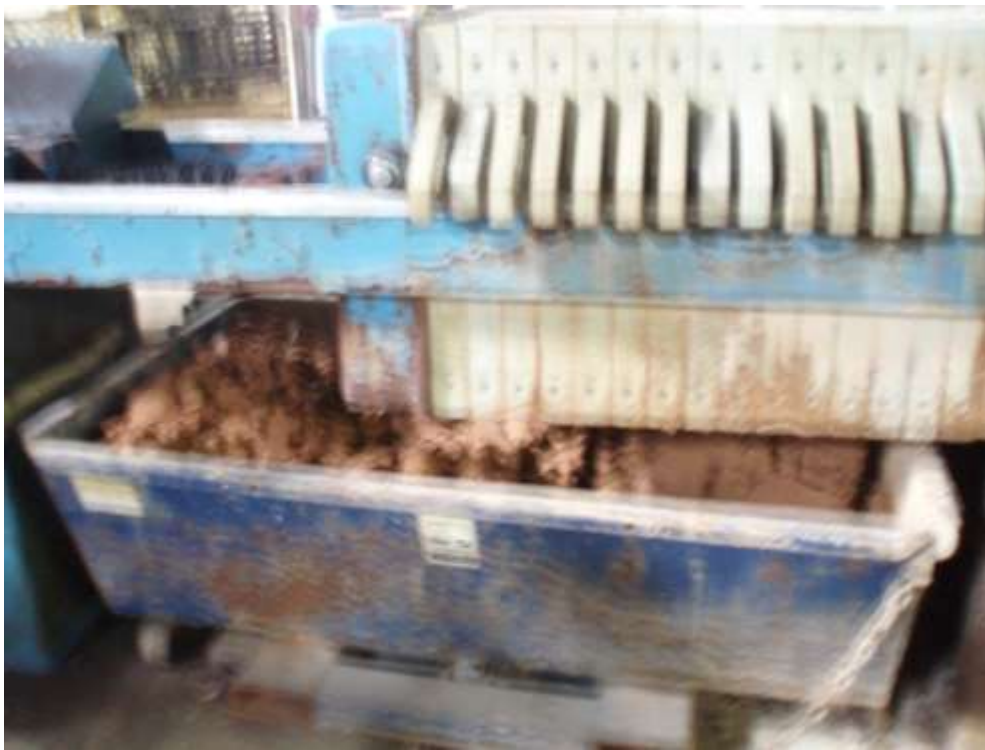
WWT unit filter press. Approximately 1 cubic yard. F006 waste water treatment sludge. Container was open, not labeled with the words, "Hazardous Waste," and not labeled with an accumulation date.

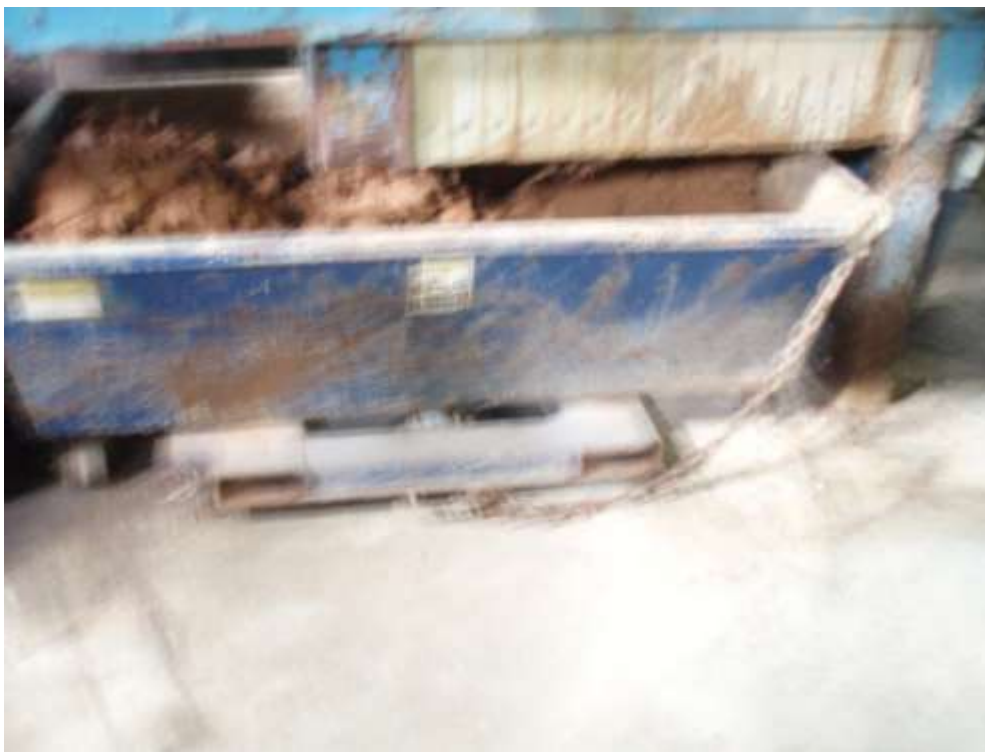
WWT unit filter press. Approximately 1 cubic yard. F006 waste water treatment sludge. Container was open, not labeled with the words, "Hazardous Waste," and not labeled with an accumulation date.

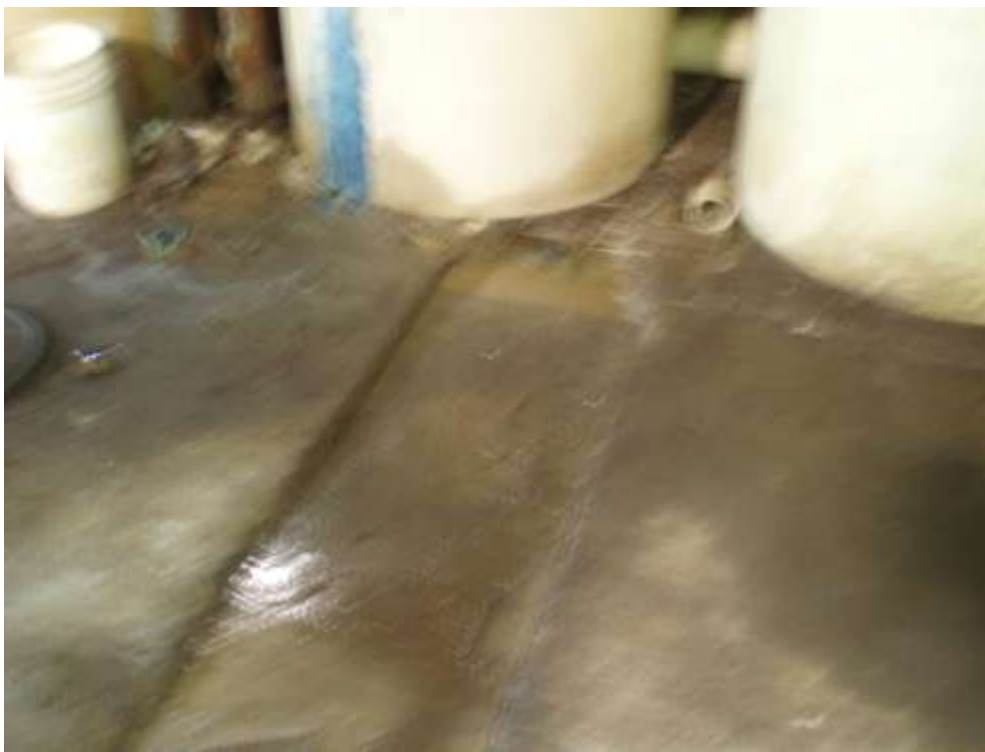
WWT unit. Liquid was located on the floor and within trench and sump pit located underneath WWT unit.

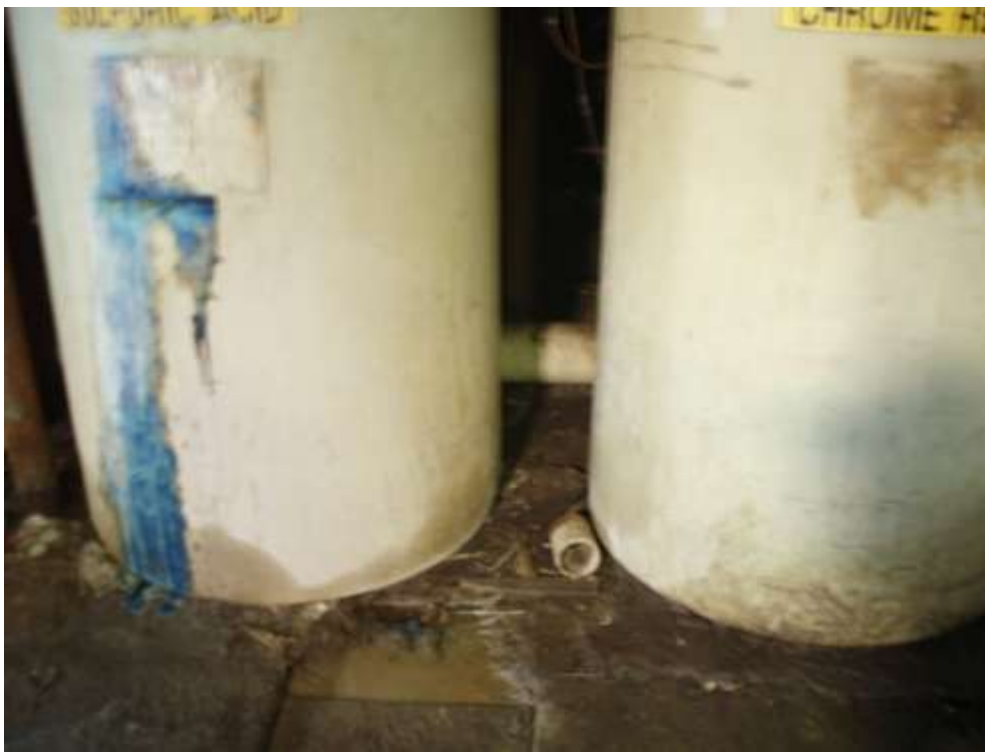
WWT unit. Liquid was located on the floor.
Blue material appeared to have leaked on the
outside of the tank labeled as, "Sulfuric
Acid."

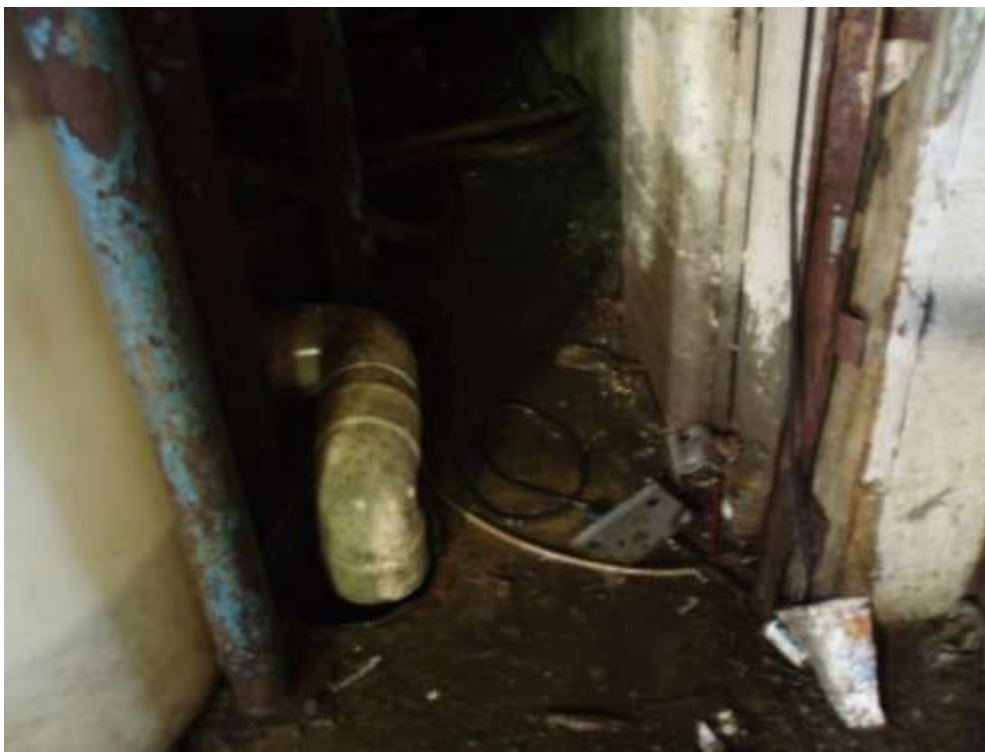
WWT unit. Liquid and debris were located on the floor. Trench and sump pit were located underneath the unit.

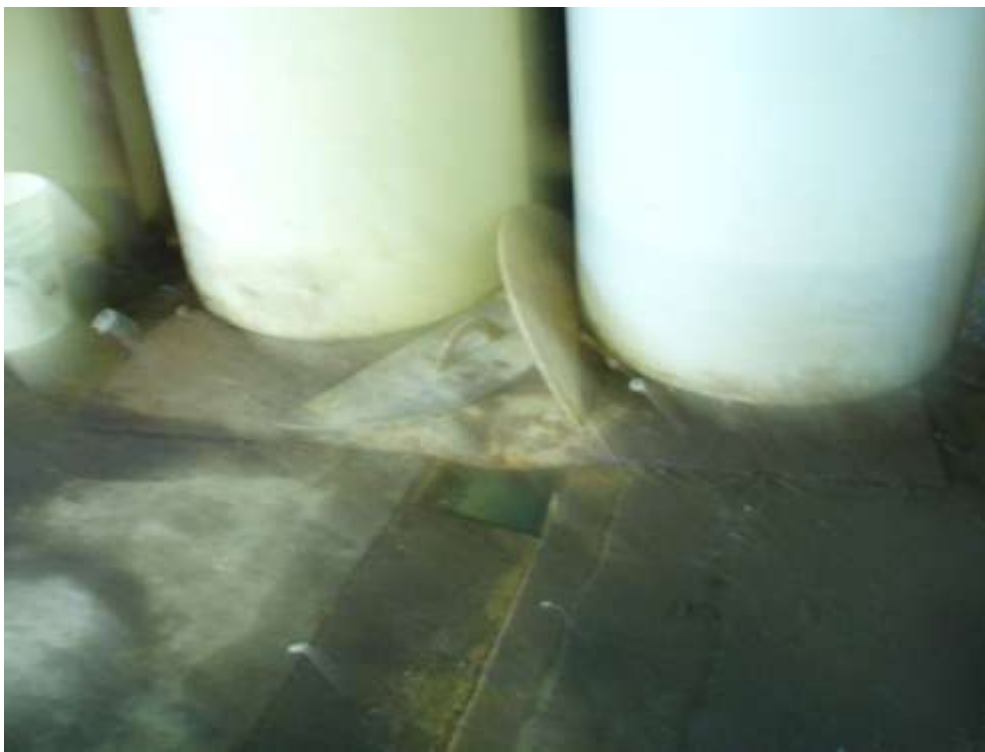
WWT unit. Liquid was located on the floor.
300 gallon sump pit was located underneath
the unit.

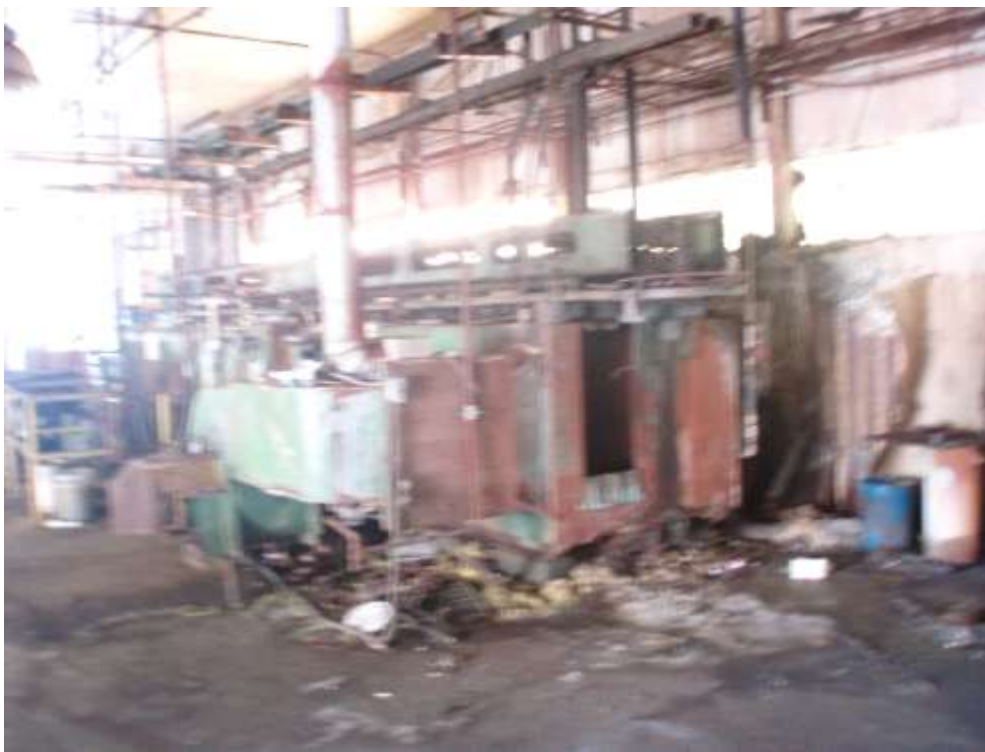
Zinc plating line. Process causes a continual spill of alkaline cleaner. Kitty litter was being placed on top of spilled material onto the floor on a continual basis. The kitty litter mix was being stored on the floor.

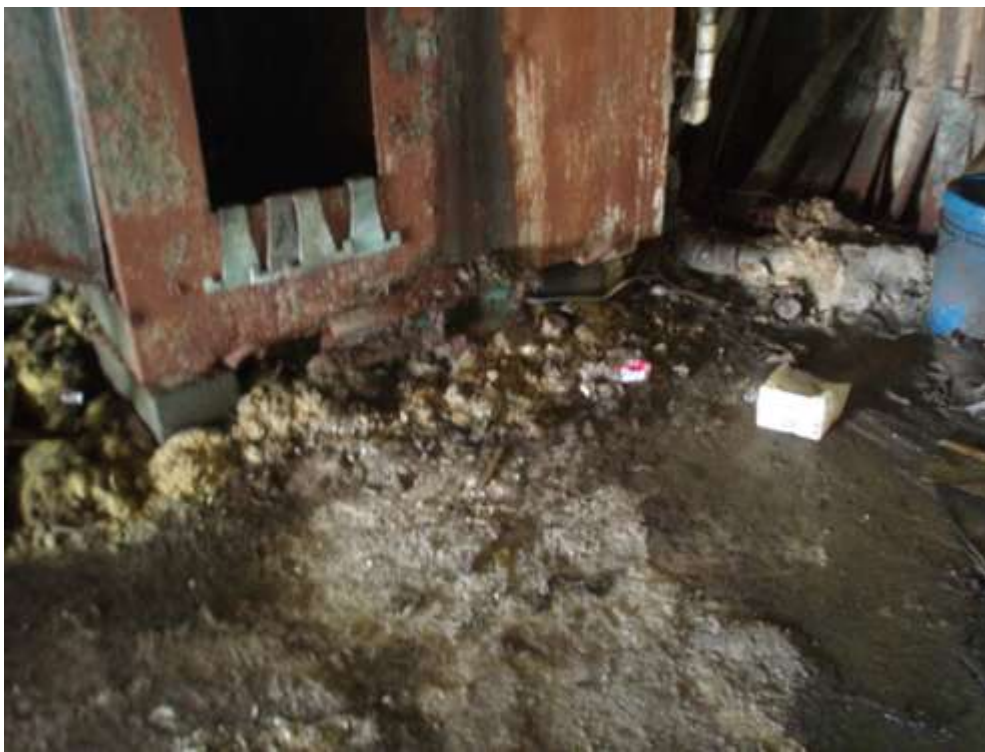
Zinc plating line. Process causes a continual spill of alkaline cleaner. Kitty litter was being placed on top of spilled material onto the floor on a continual basis. The kitty litter mix was being stored on the floor.

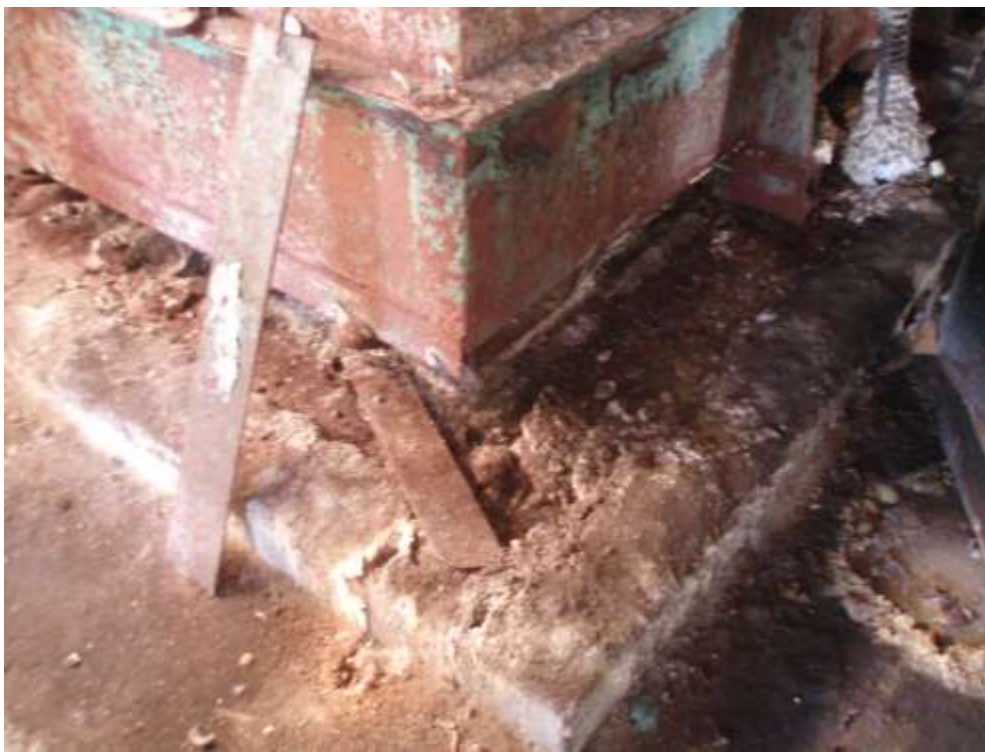
Material was being collected and stored within the containment pit below the zinc plating line.

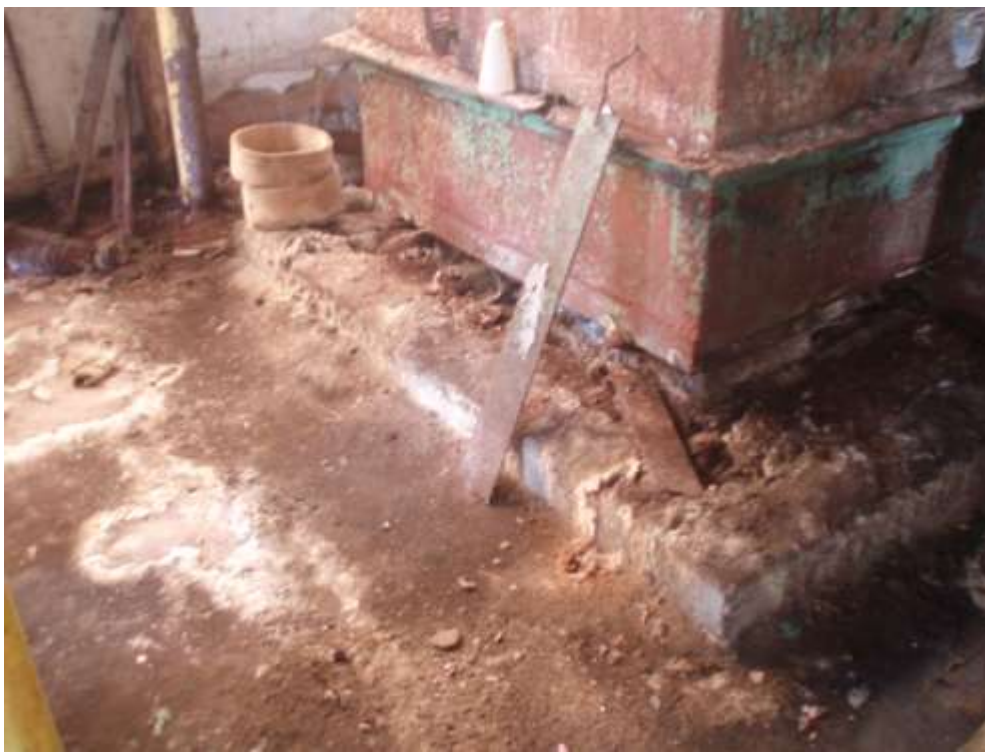
Material was being collected and stored within the containment pit below the zinc plating line. Material also was being collected and stored on the floor. Corrosion was evident on the surface of the floor.

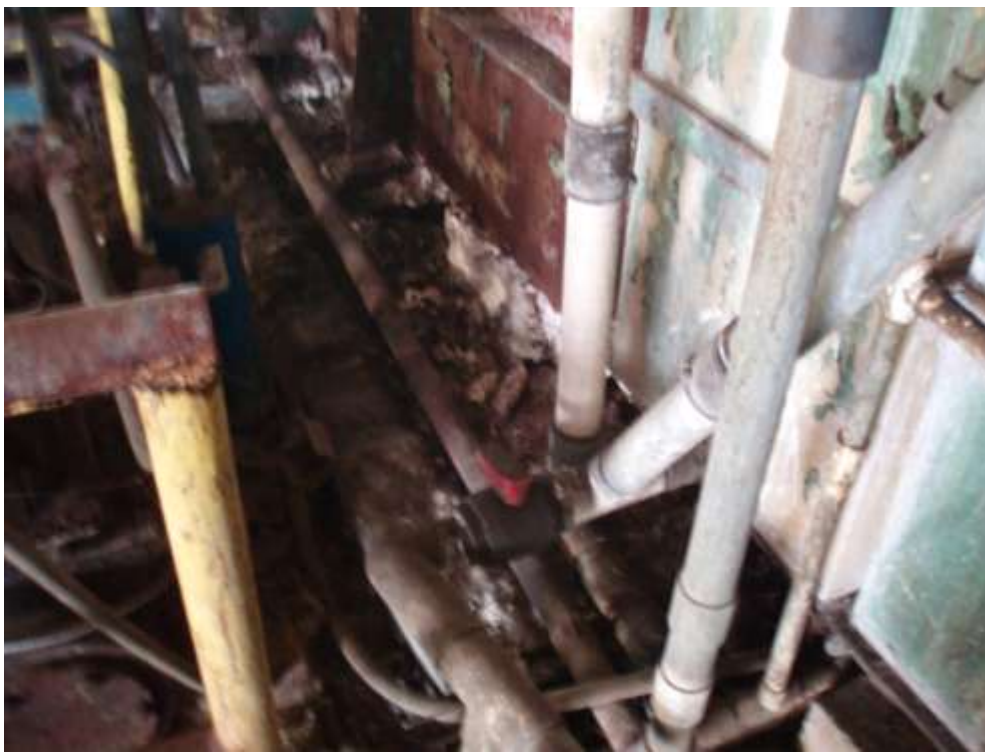
Material was being collected and stored within the containment pit below the zinc plating line. Material also was being collected and stored on the floor.

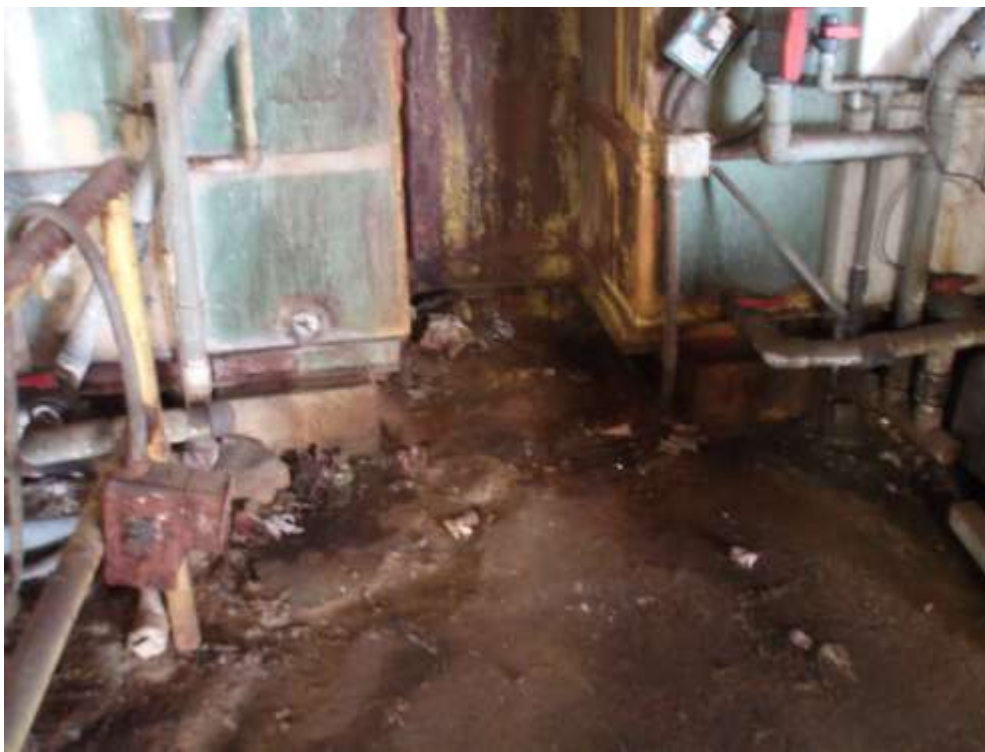
Material was being collected and stored within the containment pit below the zinc plating line. Material also was being collected and stored on the floor. Corrosion was evident on the surface of the floor.

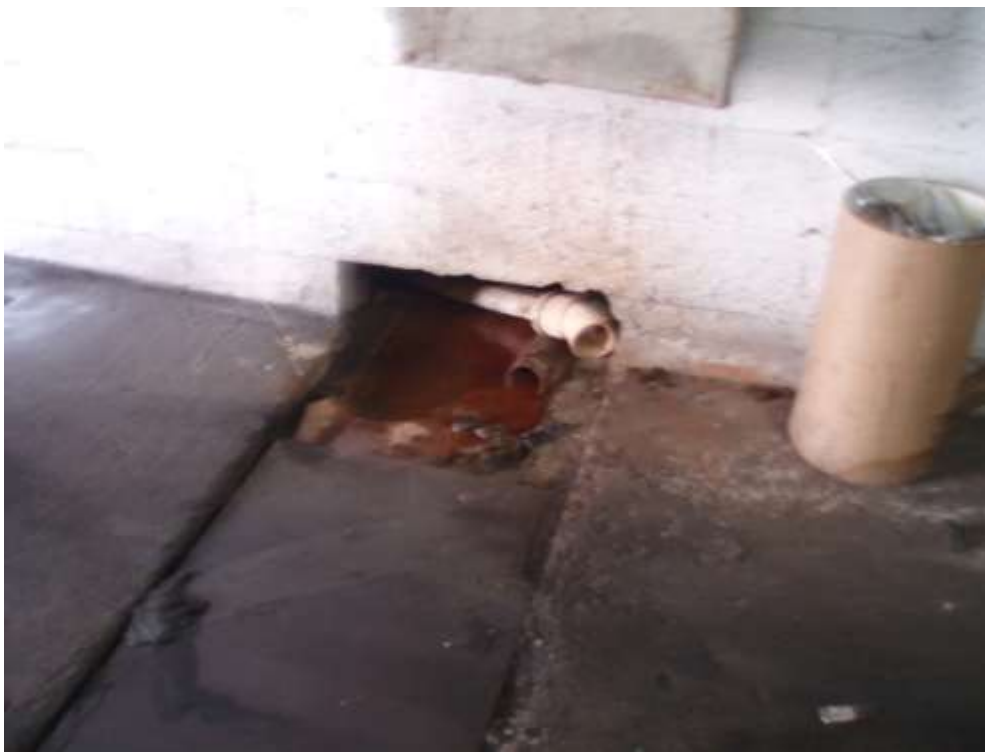
Trench located on the floor in between rooms. Red un-identified red liquid was being stored within the trench. Pipes were located inside of the trench and were not connected from the exposed ends.

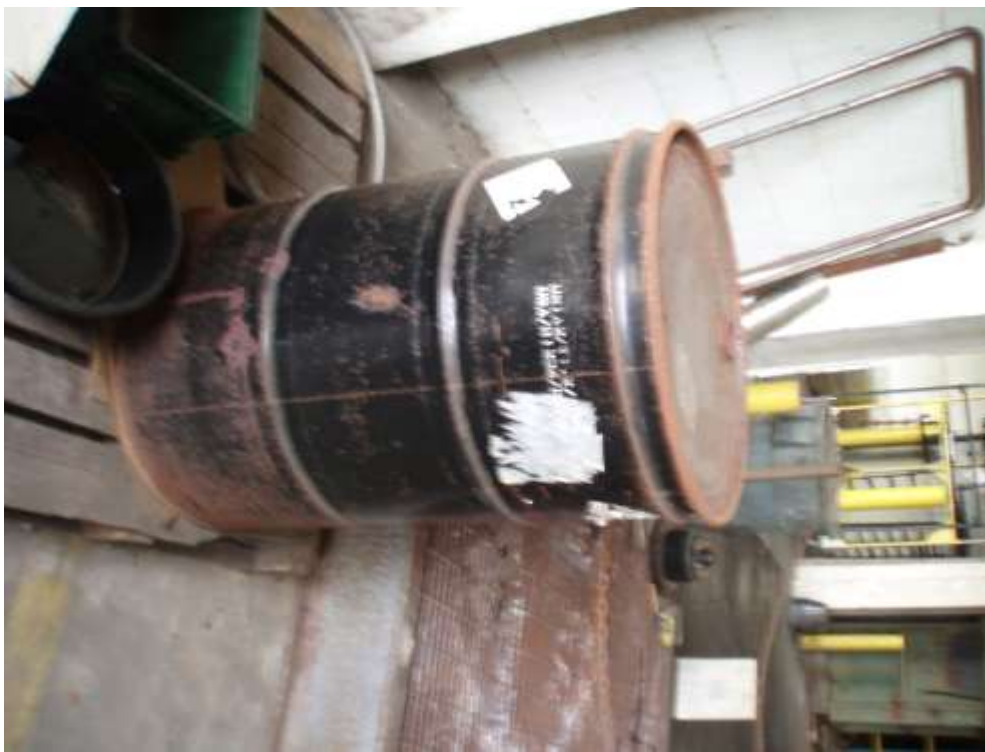
F008 hazardous waste from plating process was being stored in a 55-gallon container as a satellite accumulation area (SAA) container. However, container was not being stored at or near point of operation and was not labeled correctly.

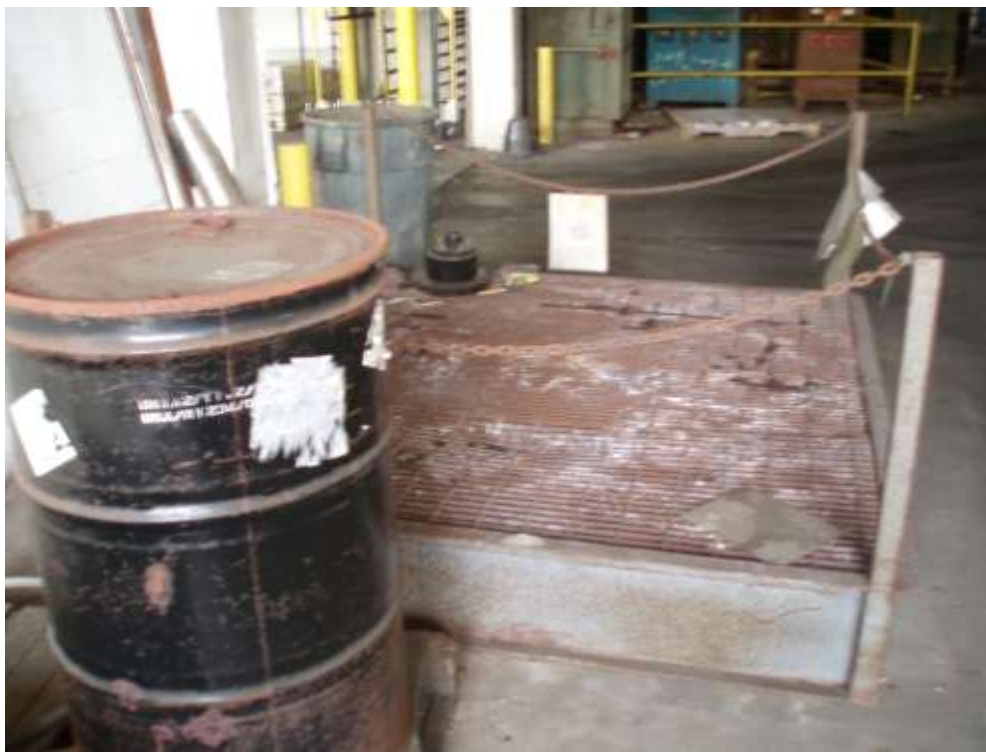
Hazardous waste storage area. SAA 55-gallon container, F008, was not being stored at or near point of operation and was not labeled correctly.

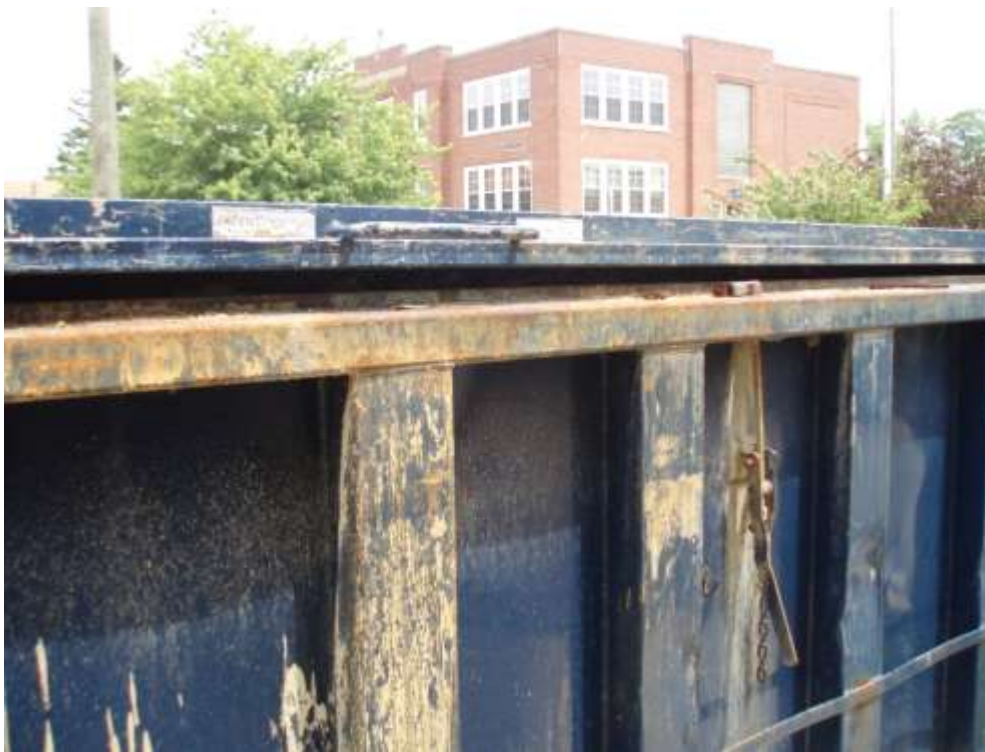
Roll-off container was located outside on the North/West side of facility. Roll-off was filled to top of container with F006 hazardous waste. Lid was not completely closed. No hazardous waste label, or date of accumulation was located on container.

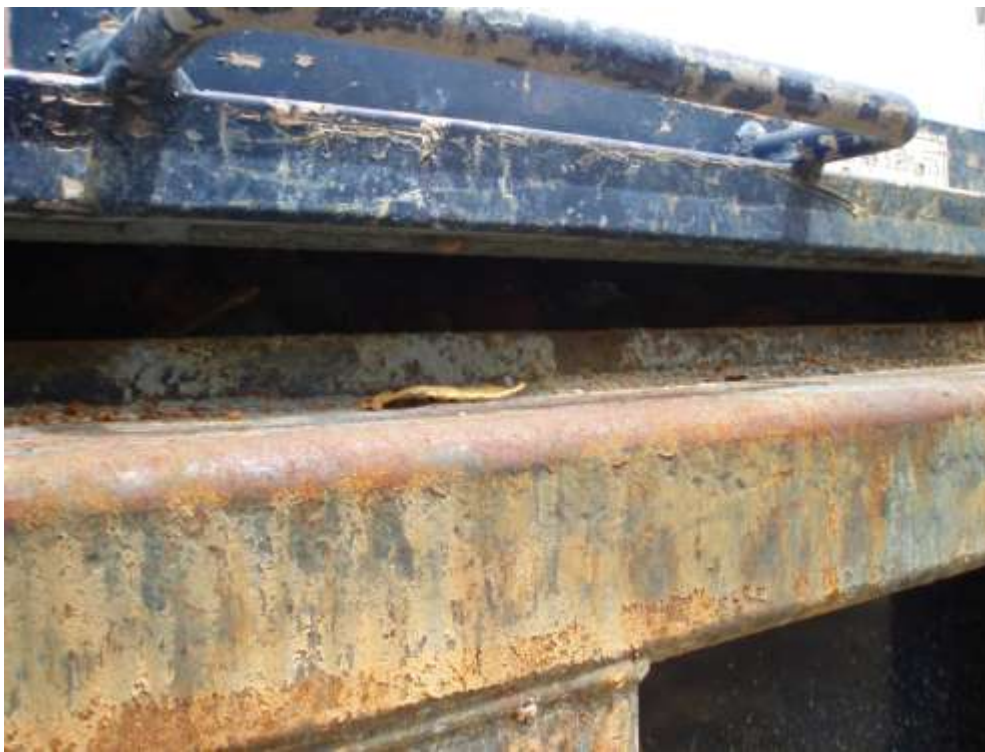
Roll-off container being stored outside on North/West side of facility. Lid was not completely closed on container. F006 hazardous waste was filled to top of container.

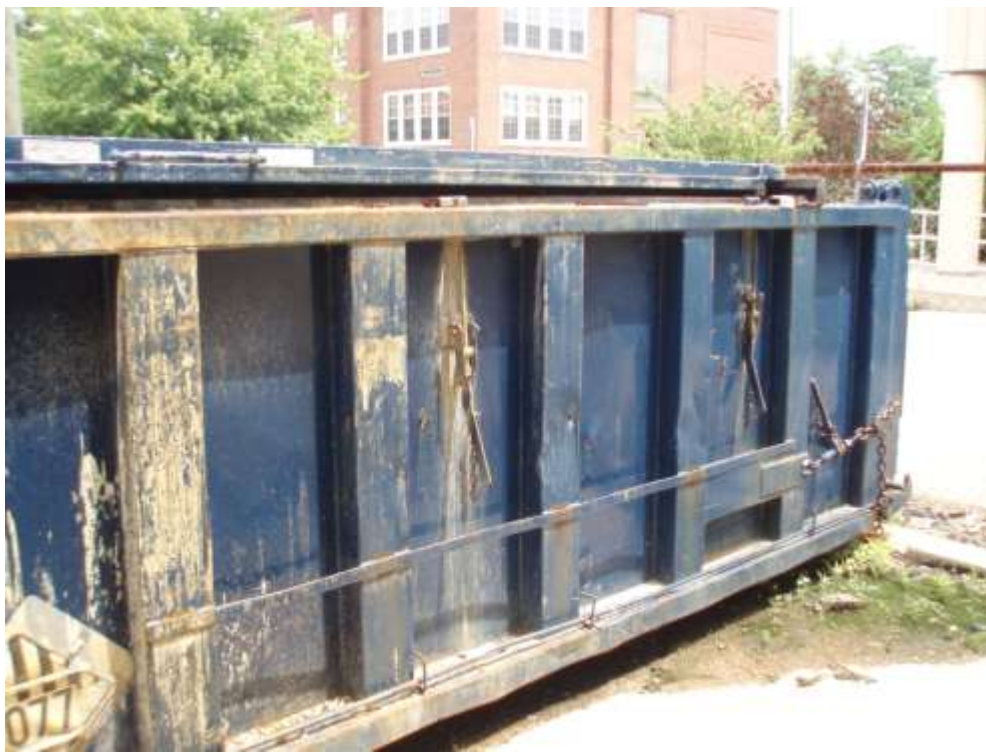
Roll-off container was located outside on the North/West side of facility. Roll-off was filled to top of container with F006 hazardous waste. Lid was not completely closed. No hazardous waste label, or date of accumulation was located on container.

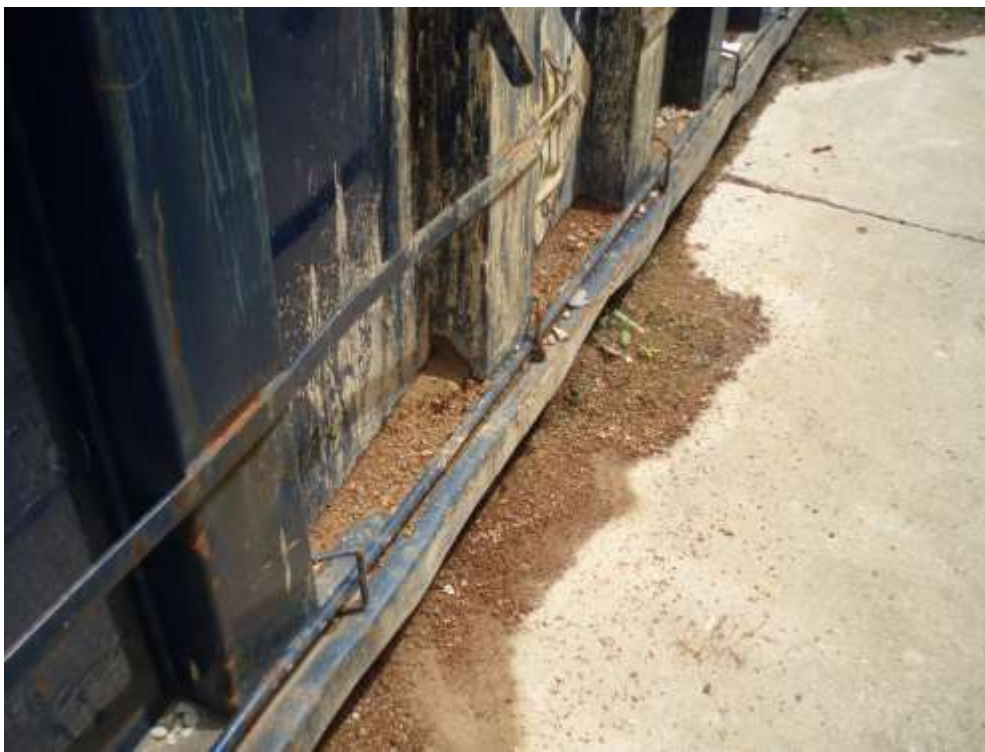
F006 hazardous waste was located on the outside of the roll-off container and on the ground.

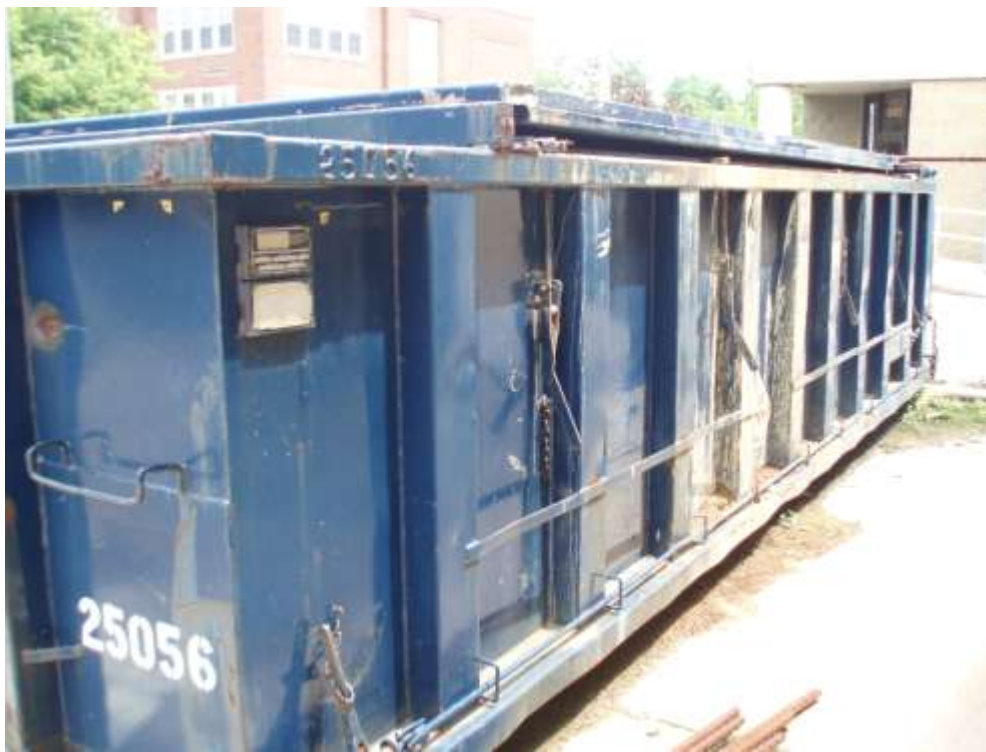
F006 hazardous waste was located on the outside of the roll-off container and on the ground.

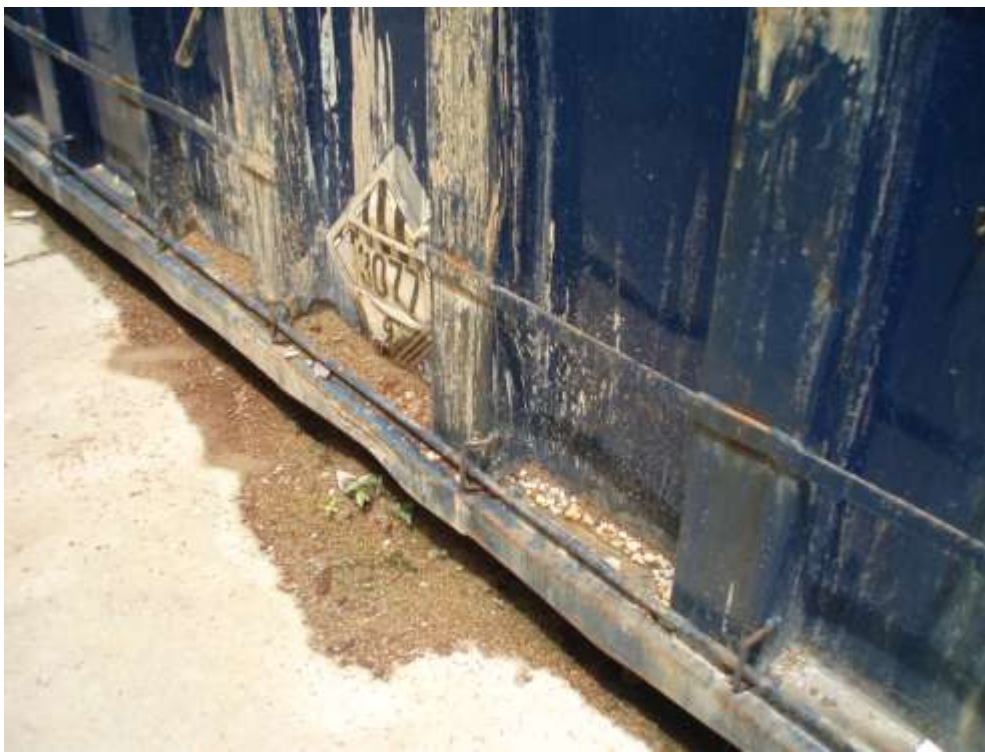
F006 hazardous waste was located on the outside of the roll-off container and on the ground.
